QA-382

Willis Redden Bank Barn
Ruthsburg vicinity
Private

INVENTORY FORM FOR STATE HISTORIC SITES SURVEY

Willis Redden Farm, Willis Redden Bank Barn

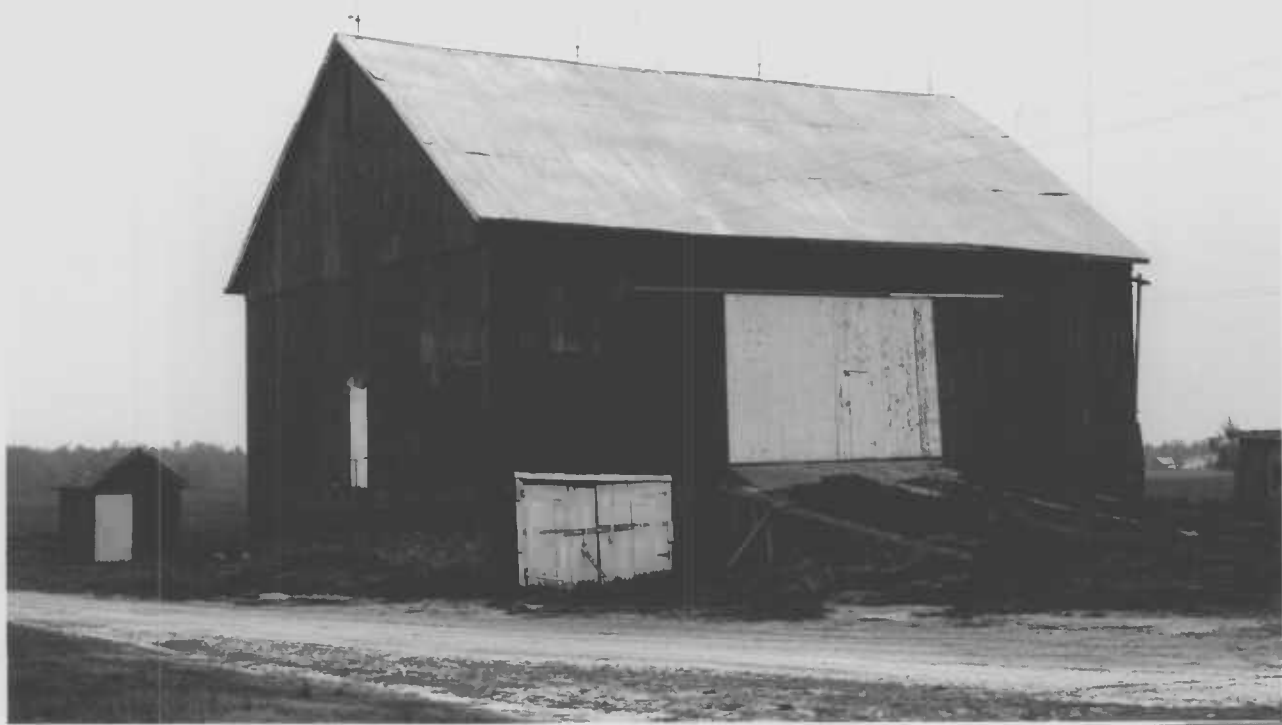
QA-382 Willis Redden Bank Barn
 Ruthsburg vicinity
 Orlando Ridout V 1980
 View from Northeast

The only opening in the east gable is a single door on the main loft floor level, mounted on machine strap hinges. Two small window openings in the foundation wall are the only openings in the west gable. Large double sliding doors on the north facade at loft floor level allow wagons to be pulled up the earth ramp and onto the central threshing floor. A smaller set of double doors to the east of the ramp on the lower ground level open into a large stable or animal pen.

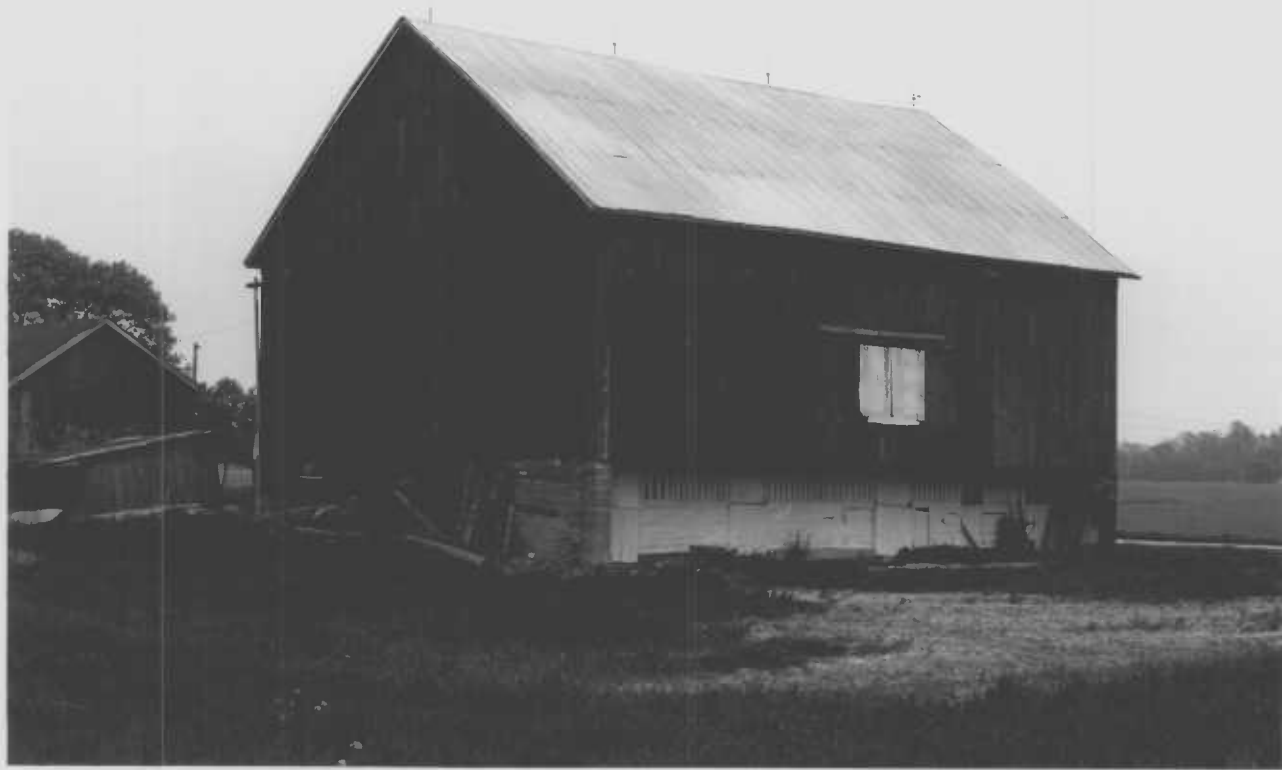
Willis Redden Bank Barn
Ruthsburg vicinity
Orlando Ridout V 1980
View from Southwest

The barn is constructed on a relatively flat site rather than the more traditional sloping or "bank" site favored in Pennsylvania. The overhanging forebay faces south toward the road, while a dirt ramp on the rear or north facade allows ready access to the upper loft area. The building rests on a common bond brick foundation and is covered with vertical board siding; the roof is tin. The gable foundation walls are carried out to the outer end of the forebay, which cantilevers out 4 1/2 feet across the entire south facade.

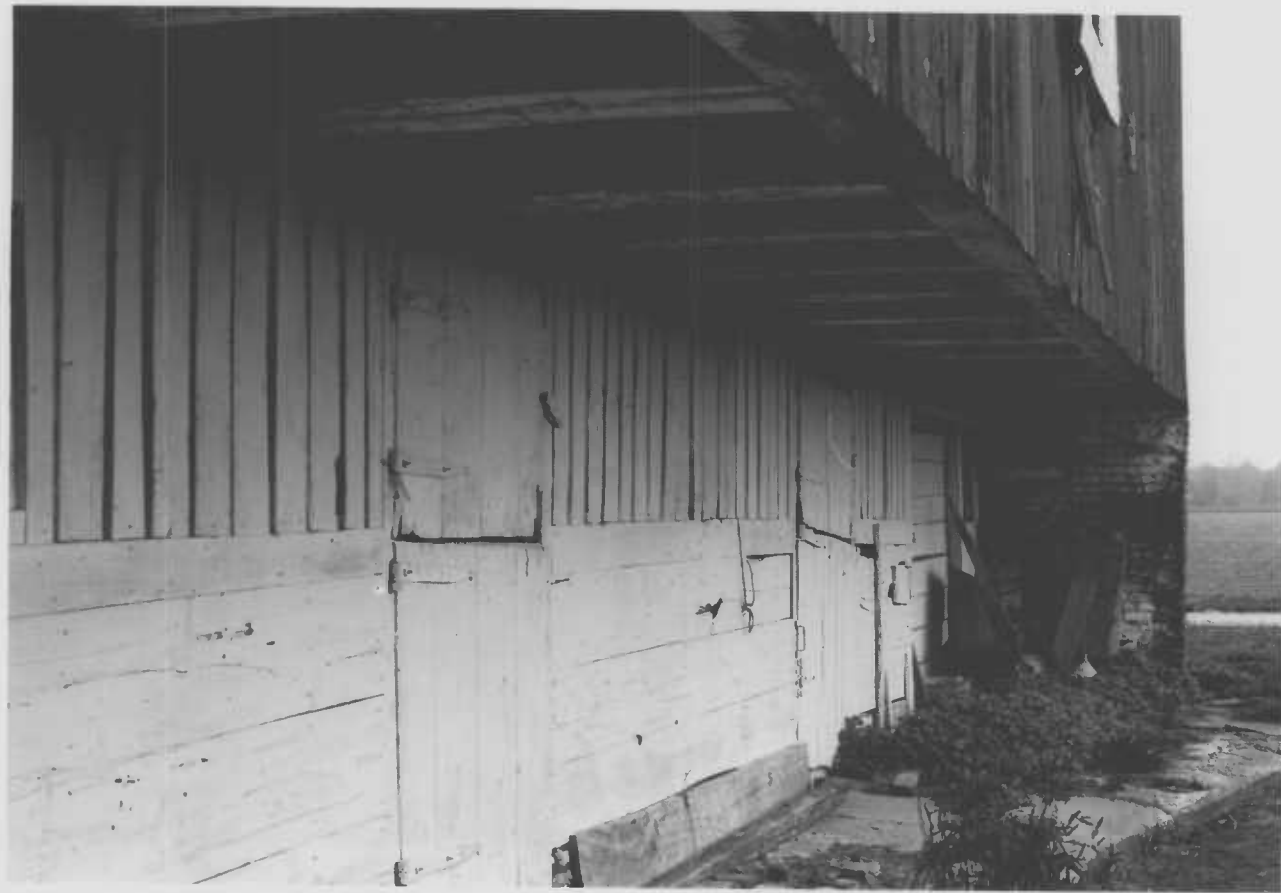
QA-382 Willis Redden Bank Barn
Ruthsburg vicinity
Orlando Ridout V 1980
Overshot forebay

There are five ground level stable doors across the protected forebay, and a relatively small loft door in the center of the main floor of the loft. Directly below this door is a second, smaller batten door hung on wrought strap hinges. The stable doors are constructed of plain vertical boards nailed to beaded battens and hung on wrought strap hinges. They are "Dutch" or double stable doors, allowing the top half of the door to be opened separately. The forebay wall is constructed of horizontal boards up to chest level, with vertical slats above that point.
